Uniform Mitigation Verification Inspection Form

Inspection Date: 5/14/2010		
Owner Information		
Owner Name: Commercial Summerwinds At Jupiter		Contact Person: Commercial
Address: 101-104 Summerwinds Lane		Home Phone: (561) 427-4432
City: Jupiter	Zip: 33458	Work Phone:
County: Palm Beach		Cell Phone:
Insurance Company:		Policy #:
Year of Home: 1984	# of Stories: 2	Email:

Elevation Photos

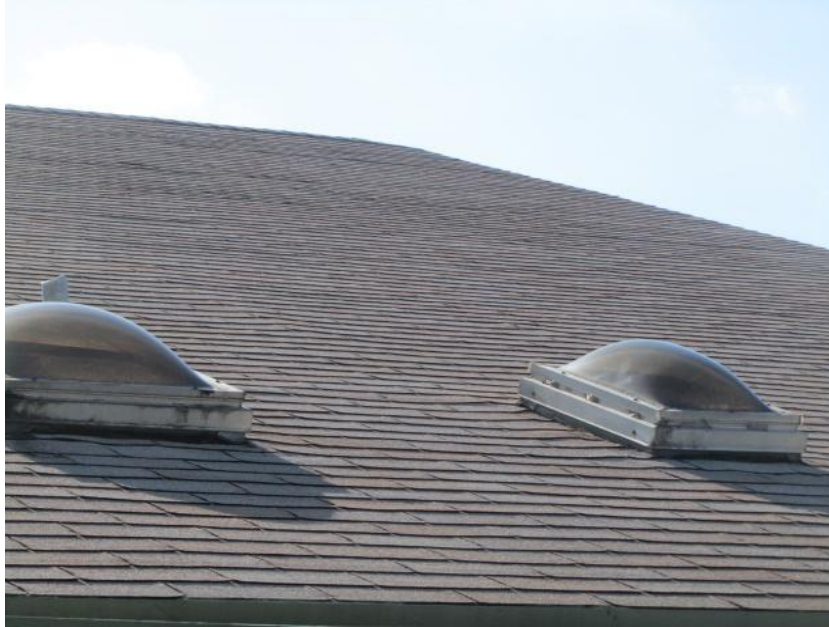
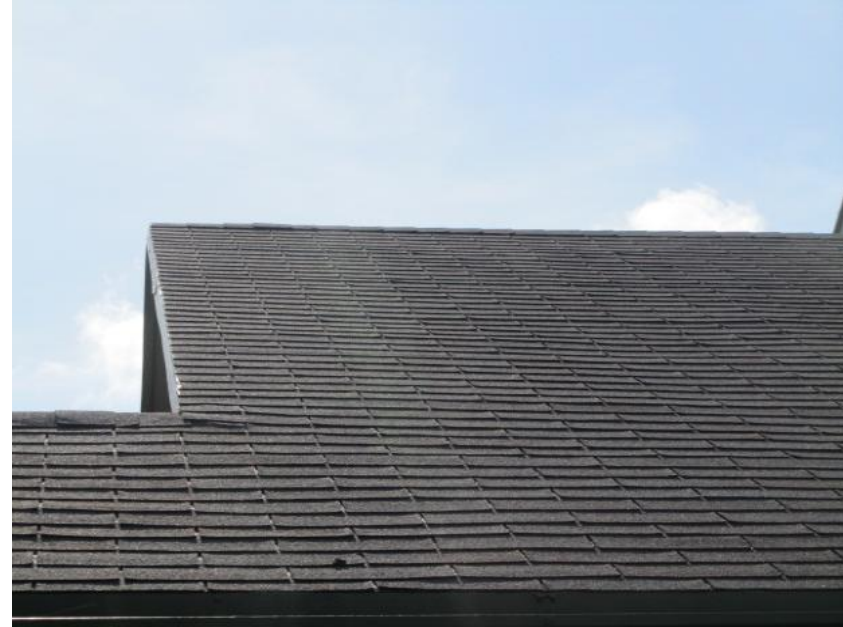
Composite Shingles

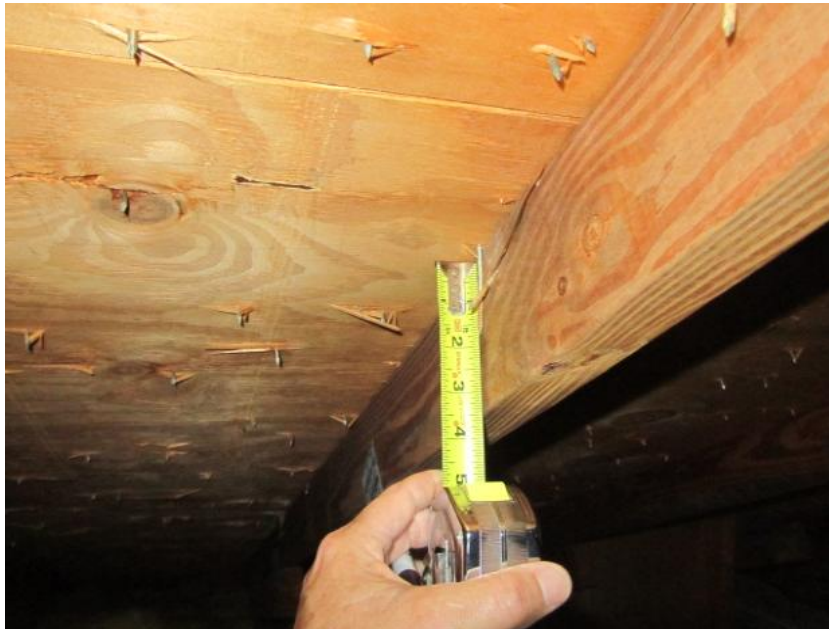
8d Nails

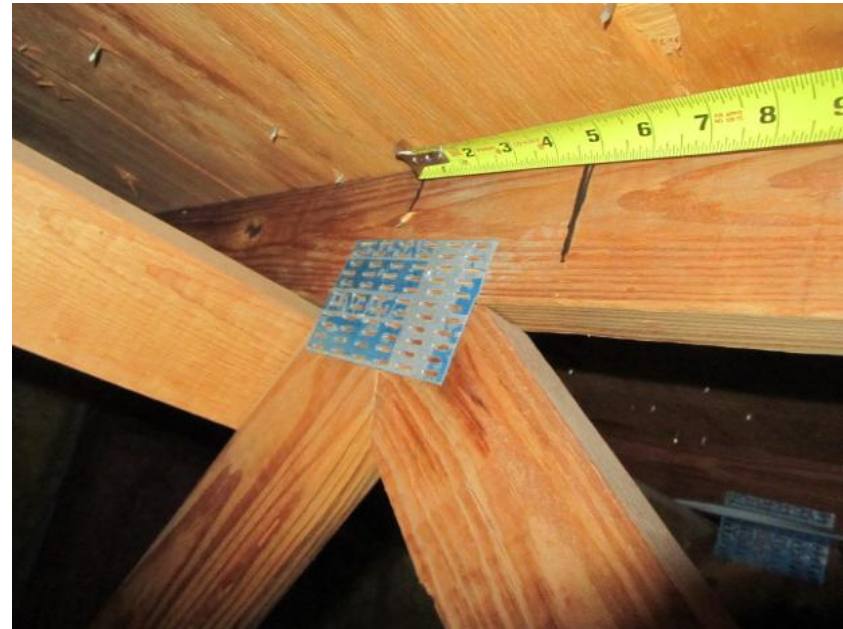
- C. Plywood/OSB roof sheathing with a minimum thickness of 7/16" attached to the roof truss/rafter (spaced a maximum of 24" o.c.) by 8d common nails spaced 6" along the edge and 6" in the field. **-OR-** Dimensional lumber/Tongue & Groove decking with a minimum of 2 nails per board. **-OR-** Any system of screws, nails, adhesives, other deck fastening system or truss/rafter spacing that has an equivalent mean uplift resistance of 182 psf.

8d Nails Spaced 6" x 6"

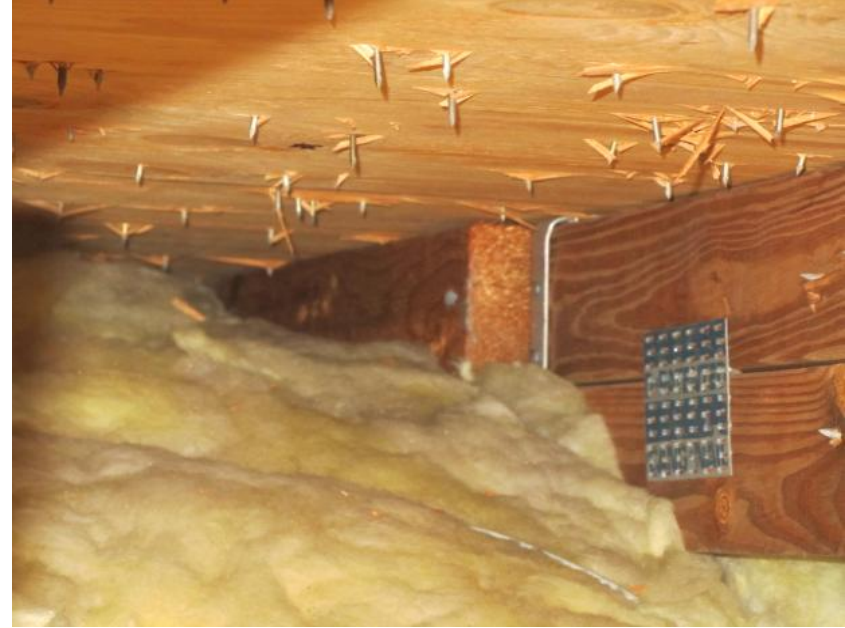
- B. Clips Metal attachments on every rafter/truss that are nailed to one side (or both sides in the case of a diamond type clip) of the rafter/truss and attached to the top plate of the wall frame or embedded in the bond beam.

Clips

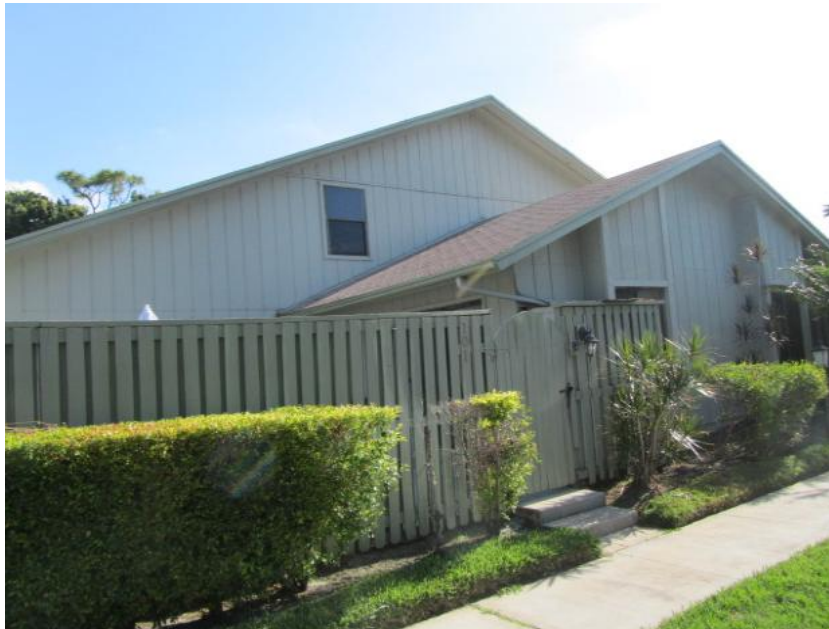
- A. Hip Roof Hip roof with no other roof shapes greater than 10% of the total building perimeter.
- B. Non-Hip Roof Any other roof shape or combination of roof shapes including hip, gable, gambrel, mansard and other roof shapes not including flat roofs.
- C. Flat Roof Flat roof shape greater than 100 square feet or 10% of the entire roof, whichever is greater.

Voiding Non-Hip Shape
